# Manhole Inspection Summary

Manhole # S33II1001MH

**Location** Address: **5 STRATFORD RD**

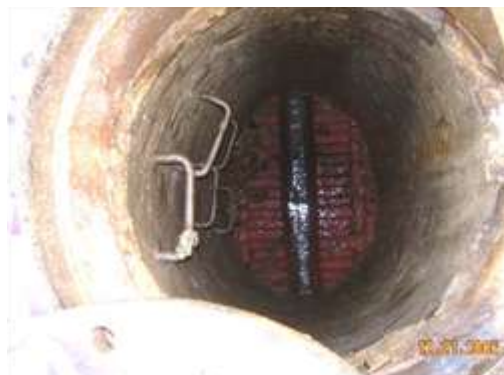
Top View

Bench debris.

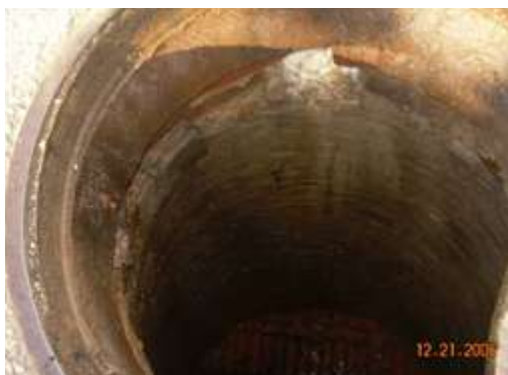
Defect

**Frame** Offset: **0** (in.) Condition: ☐ Sound ☐ Cracked ☒ **Leaks**

Condition: ☐ Sound ☐ Cracked ☐ Root Intrusion ☐ Loose Brick ☒ **Deteriorated**

Infiltration: ☐ None ☒ **Joint** ☐ Cracks ☒ **Mortar** ☐ Roots ☐ Wall

Frame leaks. Adjustment deterioration and infiltration.

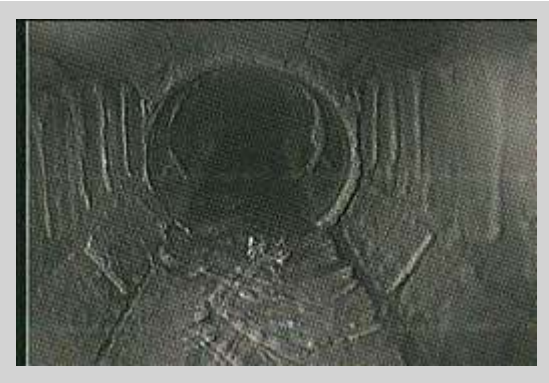
### 8 in. Circular Gravity Sewer Pipe Out @ 12 O'Clock

Infiltration: **None** Pipe Seal Cond: **Cracked**
